FINAL REPORT
ADVANCED STRUCTURAL REPAIR

*Design and Installation of Bonded Repairs
to cracked fuselage skins on C-5A T/N 69-021*

Contract F61708-94-C-0017

20 December 1995

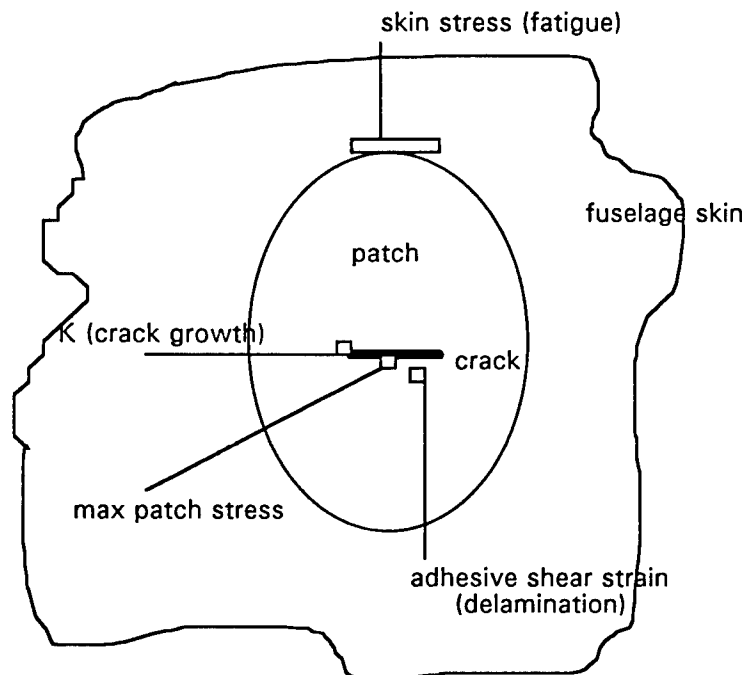
Figure 1. Critical locations in a bonded repair.

Each component is critical to a particular failure mode in the bonded repair system. For example, the *repaired stress intensity factor* at the crack tip determines how quickly a repaired crack will grow, influencing inspection intervals. The *maximum stress in the patch* over the crack helps select the patch material and thickness, while the *maximum skin stress* (at the patch tips) indicates whether a risk exists for new crack nucleation in the skin adjacent to a repair. A low *maximum shear strain in the adhesive* is important for good patch adherence and durability of the bond. Finally, the *shear load transfer length* ensures that the bond area is large enough for proper load transfer and damage tolerance.

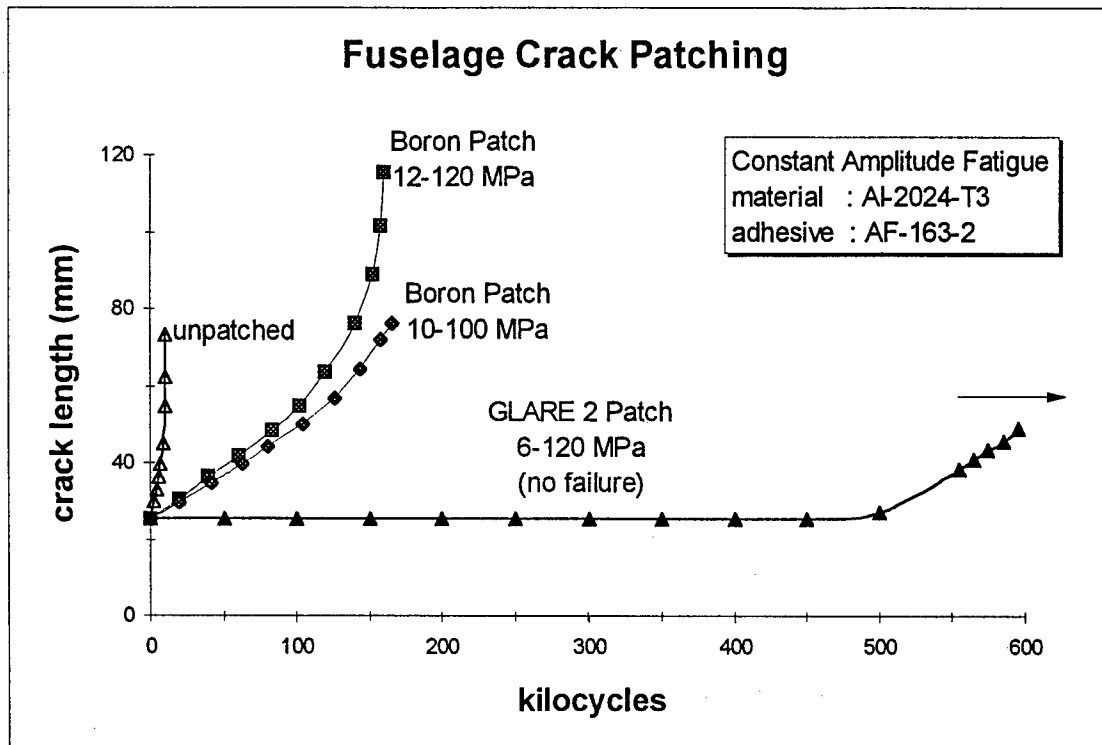
The boron/epoxy was tested at a slightly lower stress amplitude (6 MPa higher minimum stress than GLARE). This was due to the large residual curvature induced in the test panel due to the large CTE mismatch between boron and aluminum. This five percent lower stress amplitude should slightly favor the boron patch performance over the GLARE in terms of slower crack growth.

Figure 2 shows the results for an unpatched panel and both GLARE and boron patched panels. Both patches extend the fatigue life of the panel considerably over the unpatched case. However, the GLARE patched panel gave by far the longest fatigue life, showing no crack growth in the first 400,000 cycles, followed by the slowest crack growth rate of any of the repairs. The better crack-stopping performance of the GLARE versus the boron patch was predicted by the CalcuRep analysis (lowest K, lowest adhesive shear strains) and can be attributed to the better CTE match between GLARE and aluminum. By contrast, the boron repair suffers from a higher repaired K and higher adhesive shear strain values, allowing immediate crack growth, even with a lower applied stress amplitude.

Figure 2. Constant amplitude fatigue test results.
